Memorandum

To: Leslie Sims, Linda Kiefer, EPA RPMs, Lowry Landfill Superfund Site
From: Tim Shangraw (EMSI) and Lynn Robbio-Wagner (TCHD)
Cc: Steve Richtel (WM), Dave Wilmoth (Denver)
Date: March 5, 2018, Rev June 1, 2020
Re: **Evaluation of Private Wells Identified as an Issue in the 2017 Five Year Review**

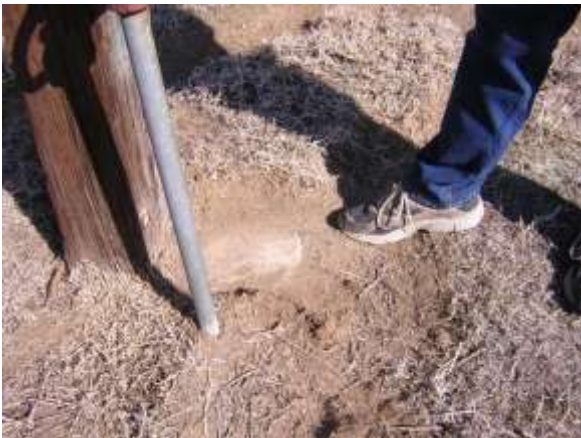
- 4) If the wells have been abandoned. Field reconnaissance of the ██████ well (permit ██████) in Section 19 (Table 1) and the Buckley Investment Company well (permit 22246) in Section 30 (Table 2) indicate these two wells have been abandoned. Photographic evidence is provided below. Another former ██████ well in Section 19 (permit ██████) was identified as inactive and partially abandoned. Photographic evidence of that well is also provided below. That well will need to be properly abandoned (discussed further below).

Abandoned ██████ well (permit ██████)

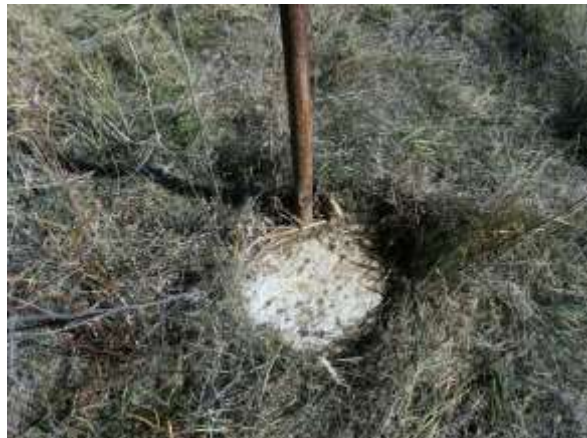
Abandoned Buckley Invest. Co. well (permit 22246)

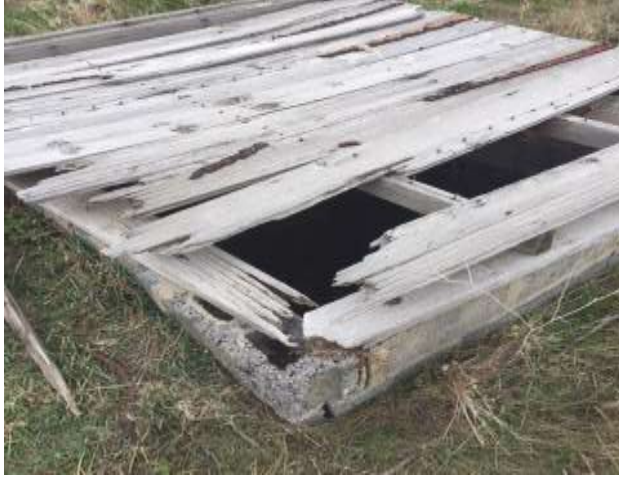
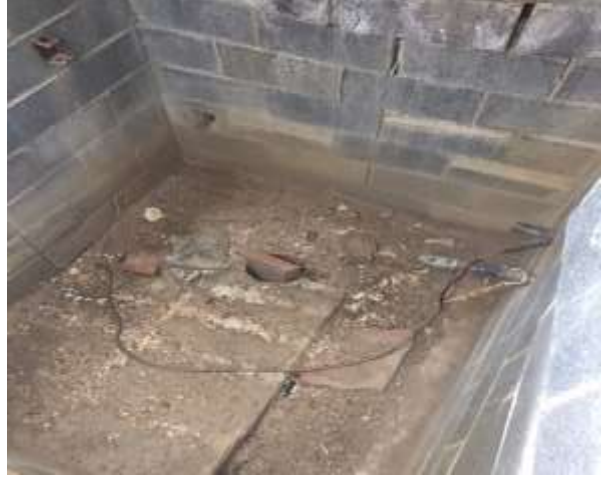
Partially abandoned former [REDACTED] well (permit [REDACTED])

Table 4 shows the resulting two private wells, the [REDACTED] and [REDACTED] wells, and the inactive, partially-abandoned former [REDACTED] well. Both of the two active, private wells are completed at depths starting at or below 357 feet bgs. The inactive, partially-abandoned [REDACTED] well is not usable, as discussed and photographed above. TCHD is working with the current owner (Murphy Creek Development Corp) to have them properly abandon the well.

- 3) A third deep well, located in Section 19, is inactive and partially abandoned. It is not usable. TCHD is working with the current owner to properly abandon the well.

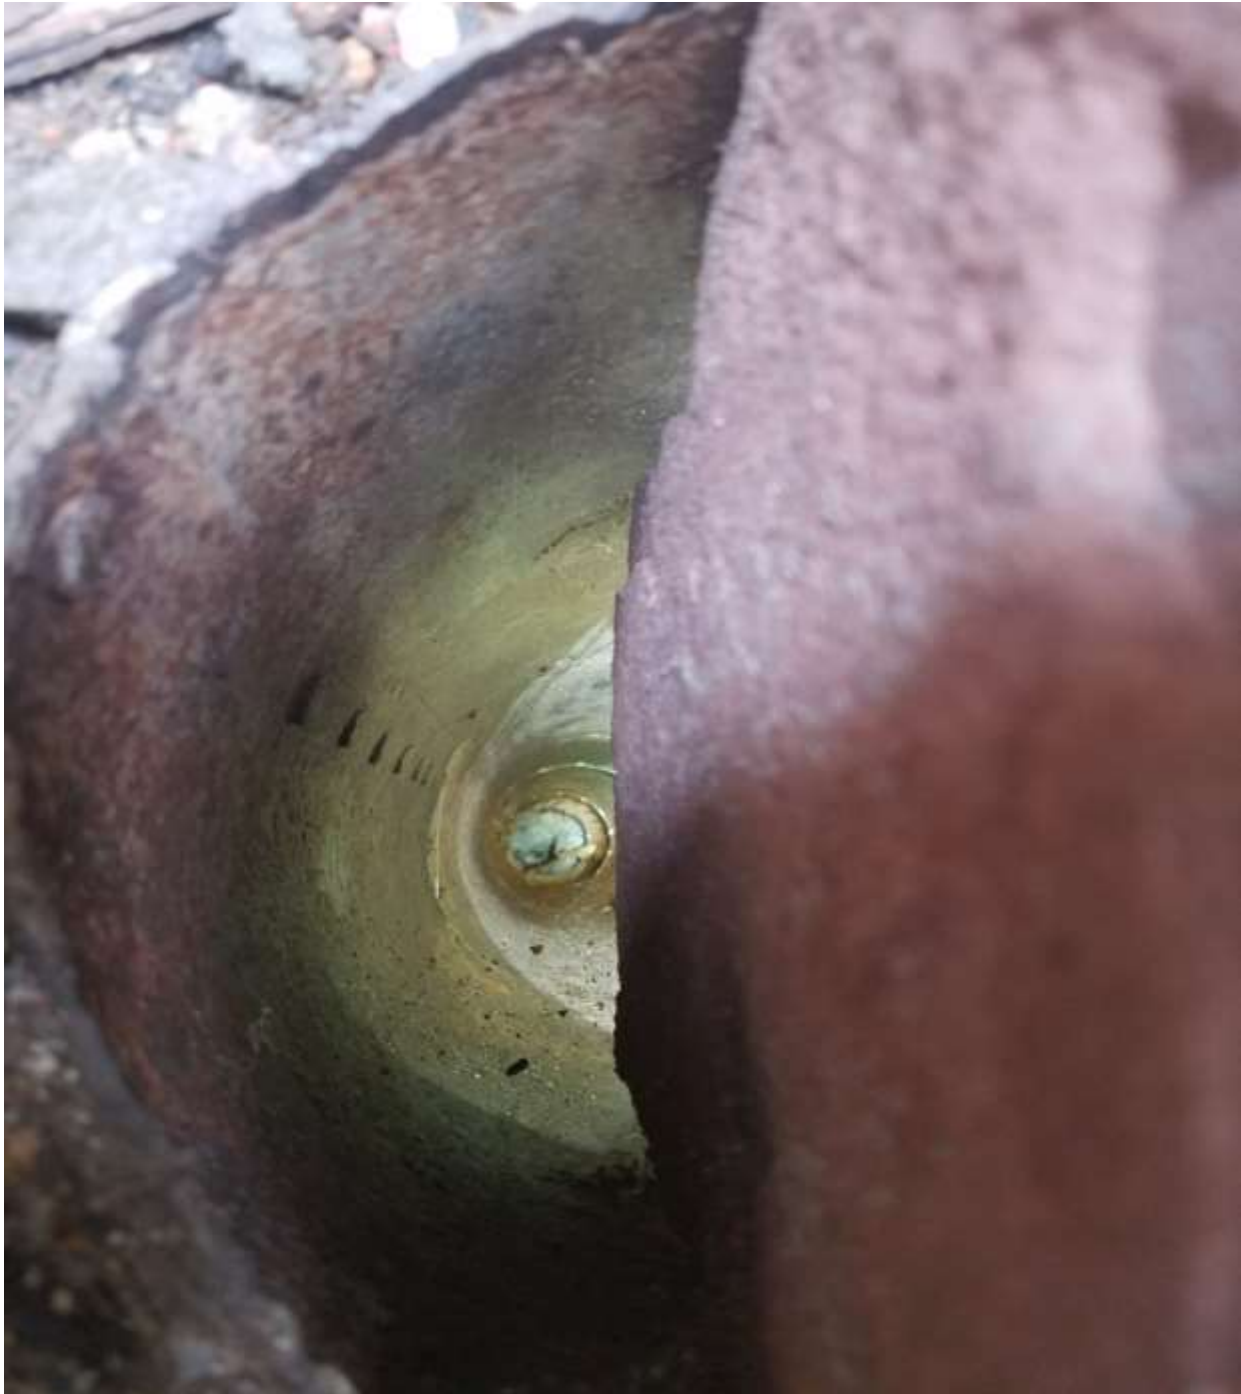
Former [REDACTED] well (permit [REDACTED]) is blocked by what appears to be grout starting 141-inches below top of surface casing. The well is not usable.
